# NA RNS-E Firmware Update Release Notes

Presented on this CD is an unofficial firmware release for the RNS-E "Audi Navigation Plus" navigation system. This release introduces a number of useful new features as well as fixing many outstanding bugs.

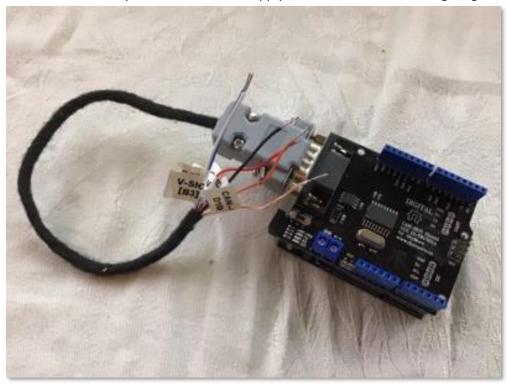
We used an Arduino Uno with an MCP2515 EF02037 CAN BUS Shield. The advantage of the Uno is that it can be run directly from the car's 12v supply as it has an onboard voltage regulator:

Note however that the Arduino's inputs are still only 5v, and the reverse gear and speed signals as 12v. You will need to buffer the input signals so as not to damage the Arduino:
