# RNS-E Firmware Update - Release Notes

Release Notes – SW 0680 / SW 0250
 192 units - SW 0680
 193PU units - SW 0250

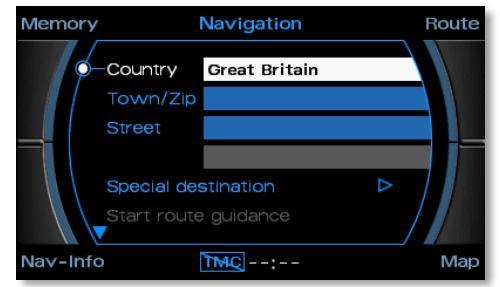
#### V220 HU/Navi SW = 192 unit

Version	Return
System SW index: 0680	
HW index: H72	
Map database index: AA_EU	J₩ 15
HU/NaVI SW Version V22008	15
Boot Version V2201000	000007
Audio Sw version Azziu 141 Social No. 4117D77E1224710	-080807
Serial No.: A02827F1234710

192 = Solid text box and frame border

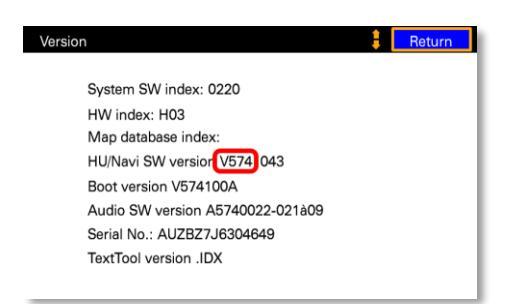
#### 193PU RNS-E (from late 2009 on)

- Maximum 2 x 32GB SDHC cards
- 800 x 480 hi-res LED screen
- MEDIA button

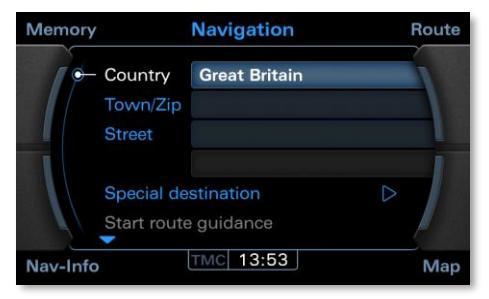
#### V574 HU/Navi SW = 193 PU unit

193 PU = Graduated text box and border

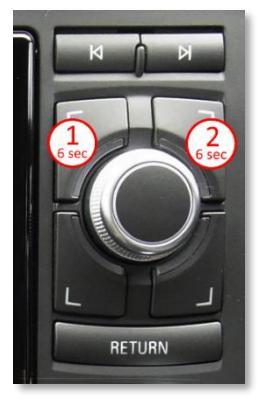
Engineering mode	📒 Return	NAV	Return	SDS	🕴 Return
General	Audio/Tuner	Nav sensor info	* Lowercase DIS units	* SDS enable	SDS log output
LOG		Location info	* Start on map	* CAR key as PTT	
NAV		GPS signal info		DDS TOOL mode	
тмс		* FIS-Control		SD writable	
		* Red DIS fix		SDS Version

Toggles for new features can be found under the Engineering Mode's "NAV" and "General  $\rightarrow$  SDS" menus. Within each menu configurable features are prefixed with an asterisk.

Disabled features are shown with a dark blue background; enabled features with a light blue/cyan background. To enable or disable an option scroll to it using the main jog control and press select.

- FIS-Control enables FIS-Control support
- Red DIS fix enables a fix for the Red-DIS cluster bug
- Lowercase DIS units displays KM/MI and AM/PM in lowercase for DIS directions
- Start on map displays the map screen, in place of destination entry, on start up

- SDS enable enables the Speech Dialogue System
- CAR used as PTT enables the CAR key to start an SDS session

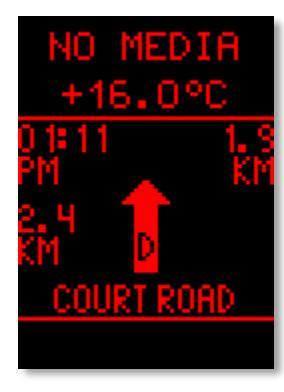
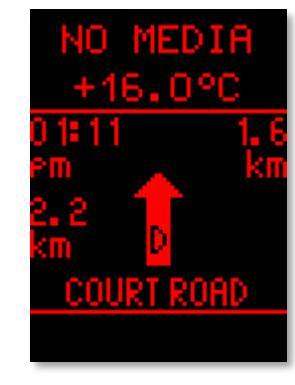
When a distance or time is displayed on the DIS by the navigation system it uses upper case, so either KM/MI or AM/PM.

With this firmware it is possible to switch to displaying these in a more pleasing lower case.

Normal Units

Lowercase Units

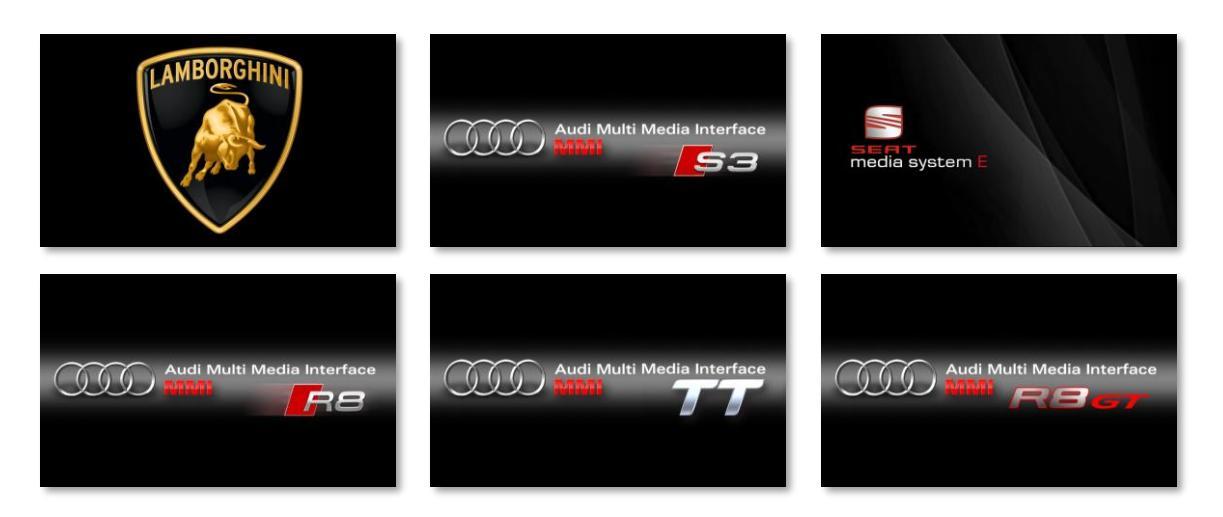
This firmware introduces the ability to code an override screen in such situations. The required override needs to be coded in addition to the true vehicle variant screen:

0??x – Override screen	0xx? – Coded vehicle variant screen
00 – use vehicle variant screen	0 – default screen
01 – Lamborghini	1-53
02 – S3	2 – S4 **
03 – S4 **	3 – RS4 **
04 – RS4 **	4 – TT
05 – TT	5 – R8
06 – R8	6 – Seat *
07 – Seat *	7 – TTS *
08 – TTS *	8 – TTRS *
09 – TTRS *	9 – R8GT *
10 – B8GT *

e.g. for a TT 8N code value 050: 05x = override to TT screen xx0 = from default screen (for A6)

The override screen is coded in the hundreds and tens positions, the true screen for the vehicle variant should be coded normally in the units position

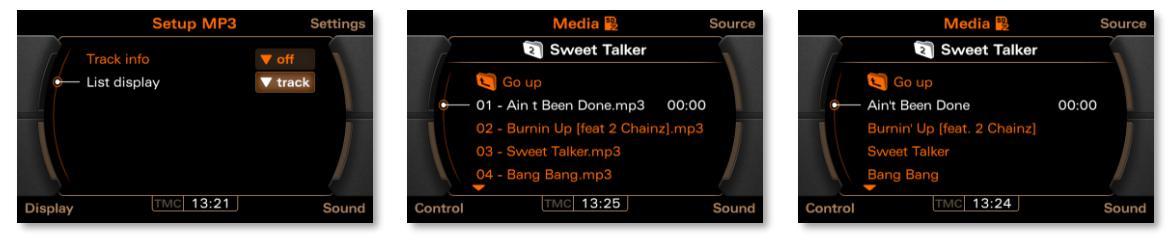
Media Setup Screen

The RNS-E scans the SD Cards for MP3 tracks and extracts the track details from the ID3 tags. You can select either filenames or ID3 tags to be displayed via the MEDIA/CD  $\rightarrow$  SETUP  $\rightarrow$  List Display – file / track option.

The 193PU units have a greater bandwidth available to the SD Card reader and so this firmware continues to run the indexer in the background. After a short while, with "track" List Display mode enabled, all tracks will be updated on screen with their ID3 tags in place of filenames.

"File" view – Filenames

"Track" view – ID3 Tags
